Understanding Spur Gear Life

TRSM0913

May 2011

All Models

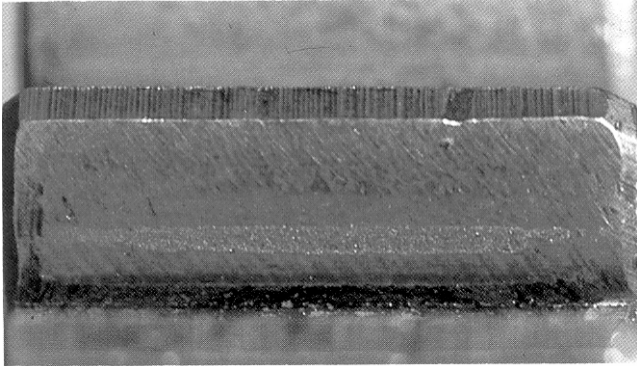
Frosting

As noted before, during mesh specific areas of the tooth surface are in contact during each stage. However, variations in the tooth form between mating teeth may produce a slight change in the contact pattern. This will result in light wear as the mating gears seek to adjust to a common pitch line. Since this wear is in a sliding zone starting near the root of the gear, it causes a form of micro-pitting. Magnification is required to see the pits. To the eye, it looks like a band of off-white discoloration called “frosting”. There is a lack of sheen at this stage.

A gear should not be replaced simply because of frosting. But if it also shows other signs of distress, such as tip loading, misalignment, severe surface irregularities, etc., then further investigation is needed. These signs will be discussed later.

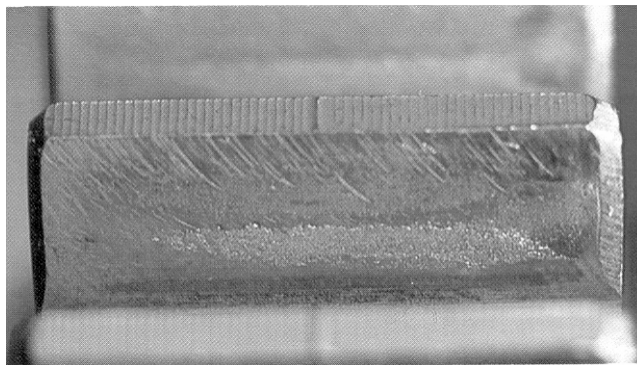
Offset Frosting

As previously stated, there are acceptable tolerances in tooth lead. Mating gear teeth can successfully operate with lead variation in opposite directions. However, a small amount of load shifting may occur. Slight wear may take place until the load is again evenly distributed across the entire tooth width. This may also result in frosting in the dedendum portion and sometimes in the addendum portion of the tooth, offset from the tooth center. Again, under normal conditions, healing will take place and gear life will not be lost.

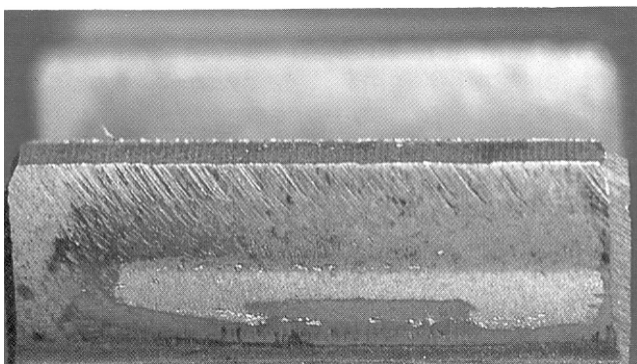
Healing

As seen in the photo, the pitch line is generally well defined. The balance of the frosting will take the shape of the contact area, no matter what it might be. Under normal conditions, the contact zone wears away; the rate of wear decreases until the point is reached where it polishes itself out and the frosting is totally replaced by a very shiny area. No further wear takes place. This is called “healing” and absolutely no gear life is lost at this stage.

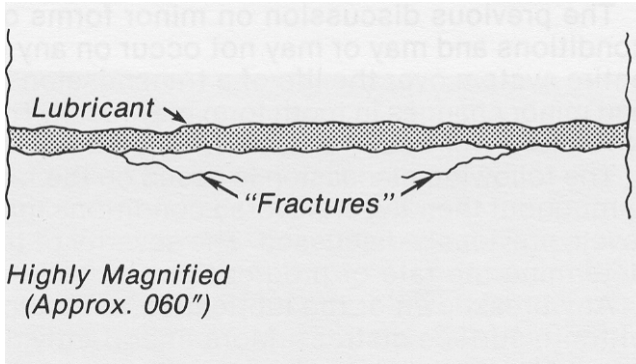
Gear Pitting

There is another surface condition which is normal in the early life of a gear and common in any carburized involute spur gear. It is the result of microscopic variations in tooth form and surface material microstructure.

Lubricant normally fills the irregularities of both teeth while in mesh. Lubricant builds a film of oil and no metal-to-metal contact takes place. Under load, oil pressures and surface stress develop between the teeth. The specific cause of this stress is debatable. One theory is that repeated high horsepower applications may cause oil pressures sufficient to overstress the microscopic areas of the tooth surface. Small surface fractures may start, and repeated loading may increase the fracture until the area is weak enough to break out, forming a pit.

The pit size will vary, depending on the depth of the initial fracture and how far the pitting has progressed. The pitting will progress until the tooth can carry the load without further distress. This rarely exceeds "initial" pitting and the distressed areas can heal

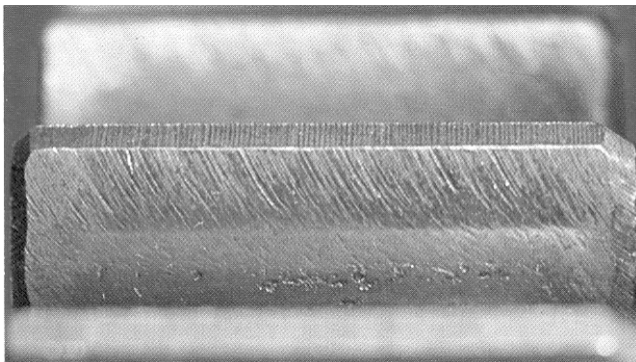
Initial Pitting

"Initial pitting" is the mildest stage of pitting. It consists of definite pits from pin hole size, just larger than frosting and barely noticeable to .030 inches (.762mm) in diameter.

Generally, initial pitting continues until the tooth is able to carry the load without further distress. Do not replace a gear because of initial pitting, as it will not cause noise and in many cases will heal over.

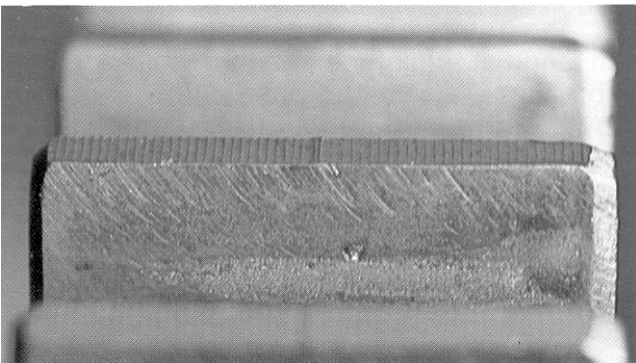
Combinations

You can see under normal operation, a gear can have a "combination" of tooth distress, frosting and/or initial pitting. Again, all are likely to heal over.

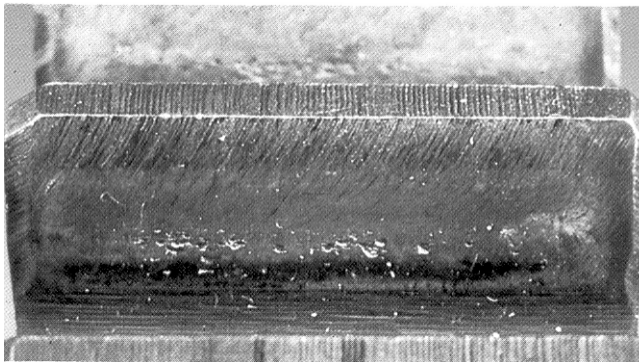
Moderate Pitting

This gear shows pit craters approximately .060 inches (1.524mm) in diameter and .005 to 010 inches (.127mm to .254mm) deep, about twice the size of craters in initial pitting. The pits are widely distributed across the face of the tooth. This gear has lived about 50% of life. The teeth have not been significantly weakened at this stage and there is no danger of breakage. As in the case with gears that show frosting and initial pitting, this type of “moderate pitting” will not cause noise. This gear can give many more miles of useful service.

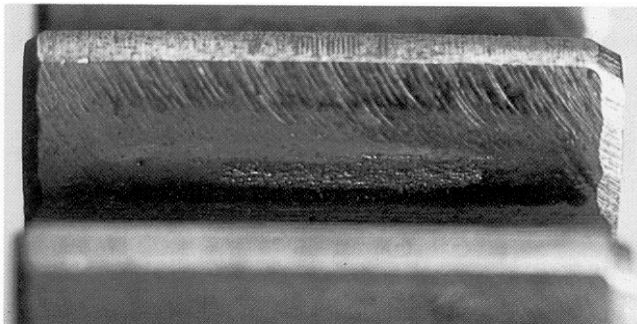
This gear also has pitting on approximately 50% of the tooth surface, but unlike the previous gear shown, this gear should be replaced. The pitting is concentrated and at the pitch line, which changes the involute form. Although the teeth have not been significantly weakened, noise can be generated because the involute form no longer falls within the tolerance band discussed earlier.

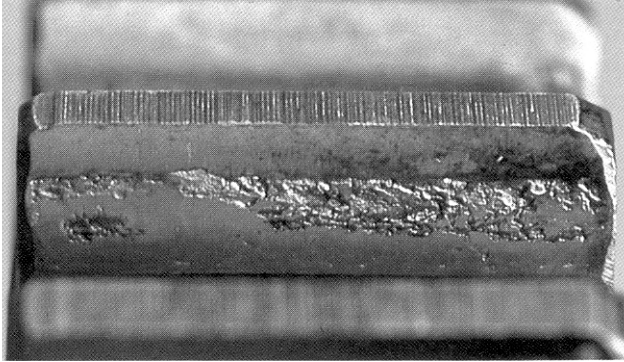
“Spalling” is similar in appearance to destructive pitting except the craters are larger in diameter and shallower in depth. Spalling occurs over a short period of time when a gear is subject to an extreme overload condition.

Major forms of distress are primarily caused by a severe case of the factors given for minor and progressive forms of distress. These forms can occur at any time in the gear's life. Whenever they occur, all gears in the set must be replaced.

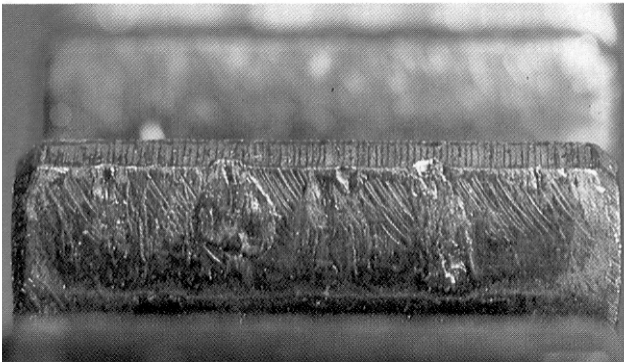
Scoring

“Scoring” is caused by an insufficient oil film between mating gear teeth, resulting in very high surface temperatures. This results in an alternate welding tearing of metal which is rapidly torn from the tooth surface. Insufficient oil film can be caused by: Low oil level, excessive transmission operating angles, high operating temperatures, poor quality, incorrect viscosity oil, and by mixing types of oil.

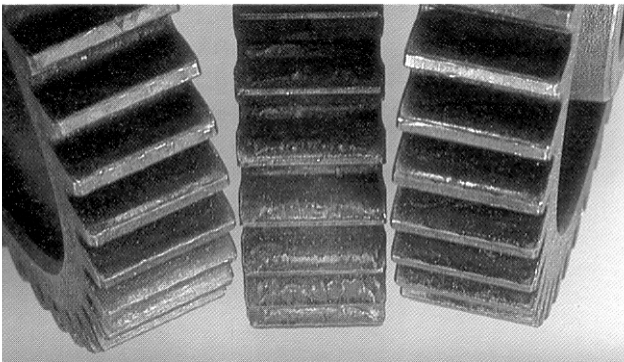
Burned Head Set

When inspecting a transmission with a “burned head set”, it is not unusual to find the main drive gear badly scored, with only slight visible damage to the mating countershaft drive gears. This occurs because the teeth of the main drive gear make contact almost three times as often as the teeth of the mating countershaft drive gears. When replacing a burned main drive gear, also replace the countershaft drive gears, even if there is no visible damage.

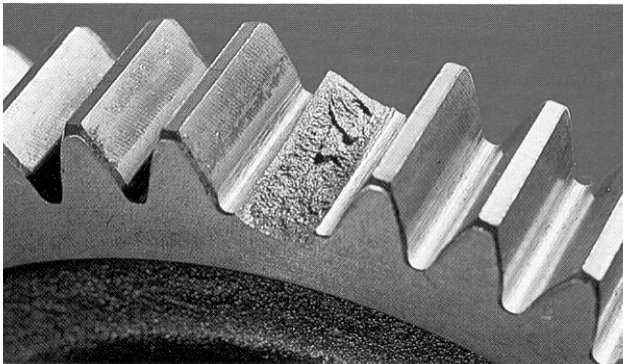
Impact Fractures

“Impact fractures” are caused by a severe shock load or a foreign object passing through the gear mesh. They are identified by a “bump” on the compression side of the fractured area. The more cycles the gear has run after the fracture, the smaller the bump will be. In addition to the gear which has a tooth fracture, the other two gears of the set should also be replaced, even though they may look undamaged. All gearing in the transmission should be inspected for possible damage caused by the broken tooth running through the transmission.

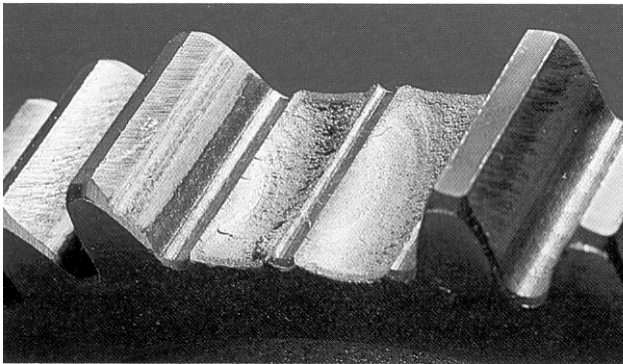
Fatigue Fractures

“Fatigue fractures” are caused by extremely high stresses on a gear tooth over a period of time.

Possible causes of such stresses could be:

- Shock loads causing a small crack in the tooth.
- Tooth damage from objects going through the gear mesh.
- An overload condition.
- Forging imperfections, excessive machining marks, or improper heat treatment.
- Severe pitting or surface fatigue.

Fatigue fractures are identified by “beach” marks on the fractured area. These marks are made as the tooth progressively cracks under a load heavy enough to enlarge the crack but not great enough to break the entire tooth off at one time.
