Understanding Spur Gear Life

TRSM0913

May 2011

All Models

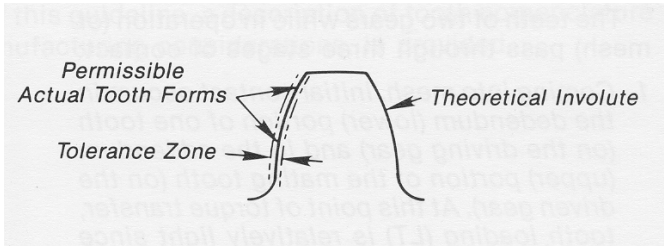
An ideal tooth shape is designed for each gear. Since it is impossible to make a perfect part, Eaton Transmission Division Engineering has determined manufacturing tolerances that will not shorten a gear's life. This figure is only an example of these tolerances, as the tooth form will change according to various design limitations. The actual tooth profile can fall anywhere with the tolerance band.

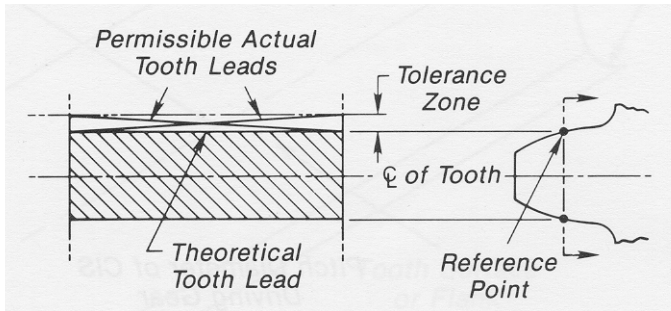
A gear tooth is also designed to be parallel with the centerline of the shaft. As with the tooth profile, certain acceptable tolerances have been determined, as shown in this figure. These close tolerances make it possible to successfully mate gears with lead variation in opposite directions without causing catastrophic failures.

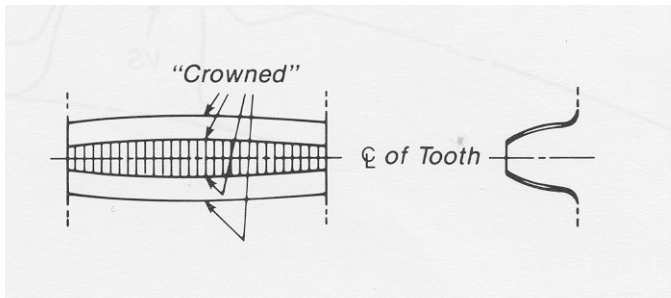
All Eaton® Fuller® transmission mainshaft gearing is "crowned". This figure is an exaggerated representation of the slight curvature machined from end to end on a mainshaft gear tooth. Crowning prevents highly concentrated end loads which might cause surface damage.

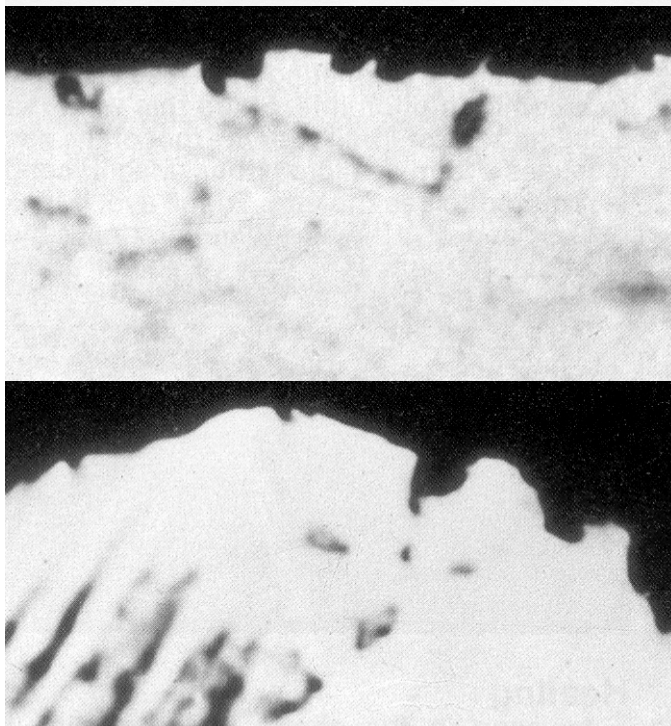
Under magnification, even the smoothest looking surface has irregular hills and valleys. This is illustrated by the two comparative photos magnified 600 times. The top photo shows the pilot bearing surface of the input shaft (.127 mm).

The bottom photo shows the surface of a gear tooth. In both photos, the width of the surface shown is approximately .005 inches
